HOLLOW-CORE FLOOR SLAB PERFORMANCE FOLLOWING A SEVERE EARTHQUAKE

A thesis
submitted in partial fulfilment
of the requirements for the Degree
of
Doctor of Philosophy
at the
University of Canterbury
by
Jeffrey Matthews

University of Canterbury
Christchurch, New Zealand

2004

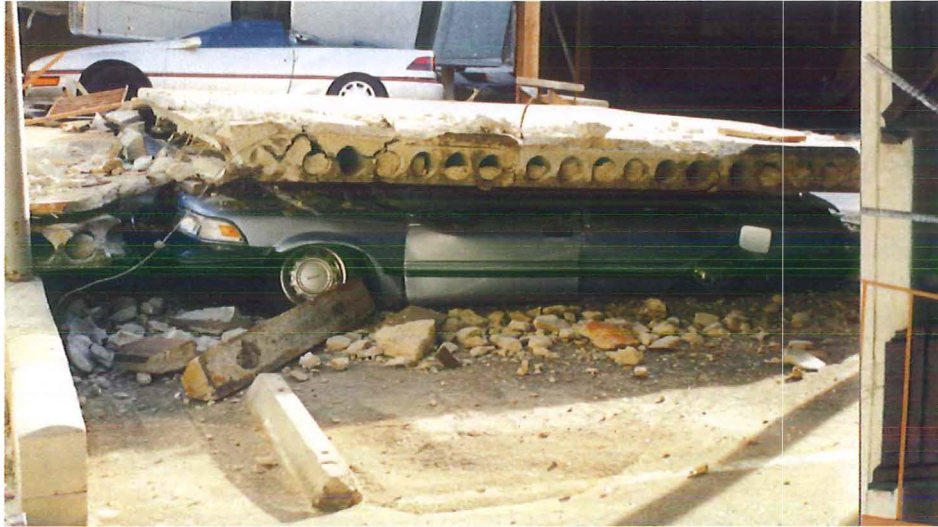
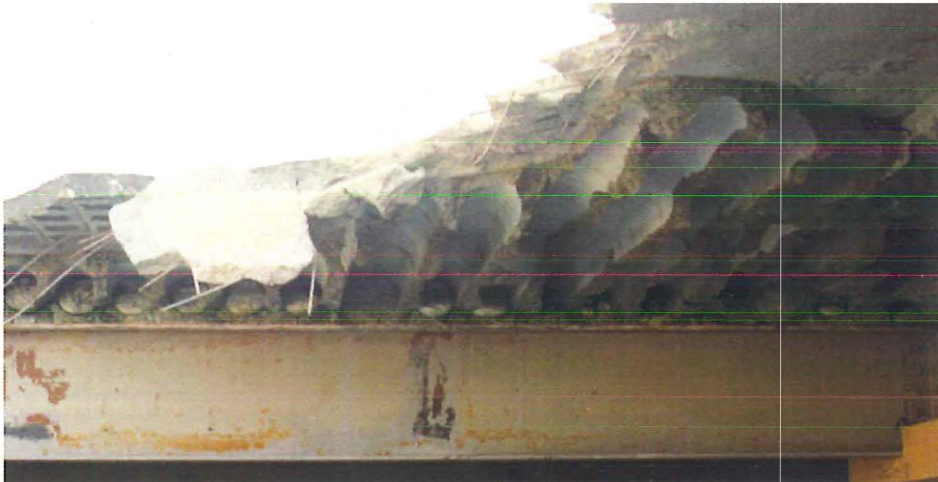
Figure 1-1 Failure of the Meadows Apartment car park, Northridge 1994 (Norton et al, 1994)

(a) Collapse of a complete section of floor

(b) A section of cast insitu topping remains while the hollow-core unit has delaminated and collapsed

(c) A section of the hollow-core units webs have split. The bottom section has collapsed while the top section remains attached to the topping

Following the January 1994 Northridge earthquake, the New Zealand Earthquake Society sent a reconnaissance team to Northridge to learn from the observed failures. The published report (Norton et al 1994) summarised the findings and observations from the reconnaissance trip. One particular case study was on the poor performance of the Meadows Apartments. Within this group of structures, there was a collapse of a portion of the car-parking building. This failure appeared to be due to the hollow-core unit losing its seat and collapsing. From the photographs in Figure 1-1 it is possible to see that there were several ways a hollow-core floor could fail. The first, being the hollow-core unit loses its seat and collapsing as a complete unit (Figure 1-1(a)). The second is the hollow-core unit separating from its topping slab (referred to as delamination) and collapsing, leaving the topping slab intact (Figure 1-1(b)). The third is the splitting of the hollow-core units webs leaving the topping slab and the top half of the hollow-core unit intact while the bottom of the unit collapses (Figure 1-1(c)).

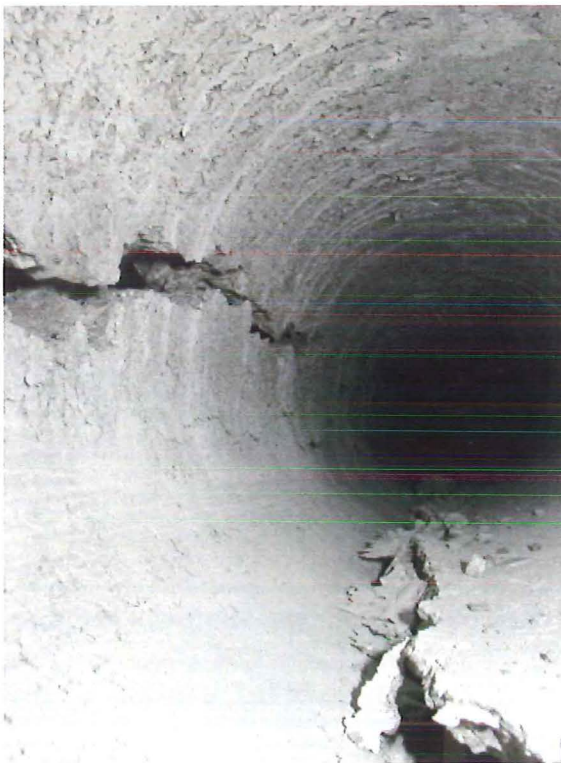
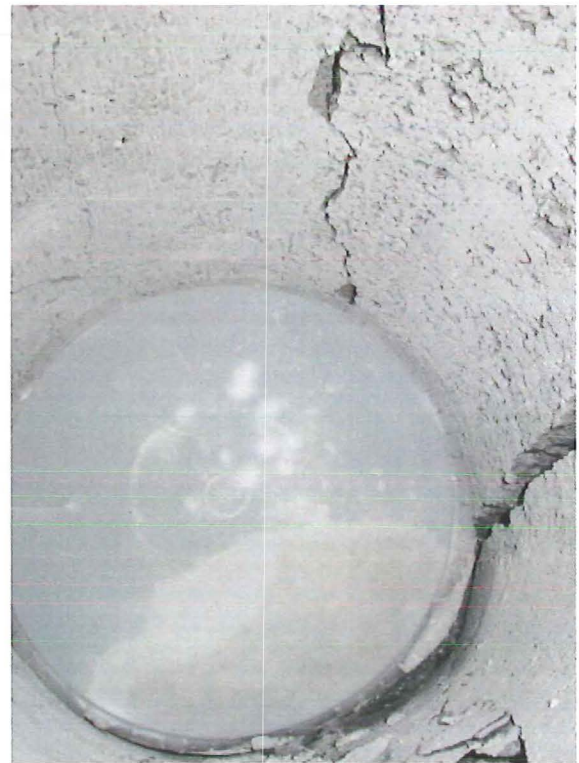
(b) Looking East. Large cracks are seen in the web and the soffit of the unit

(c) Looking West. Several cracks can be seen around the dam.

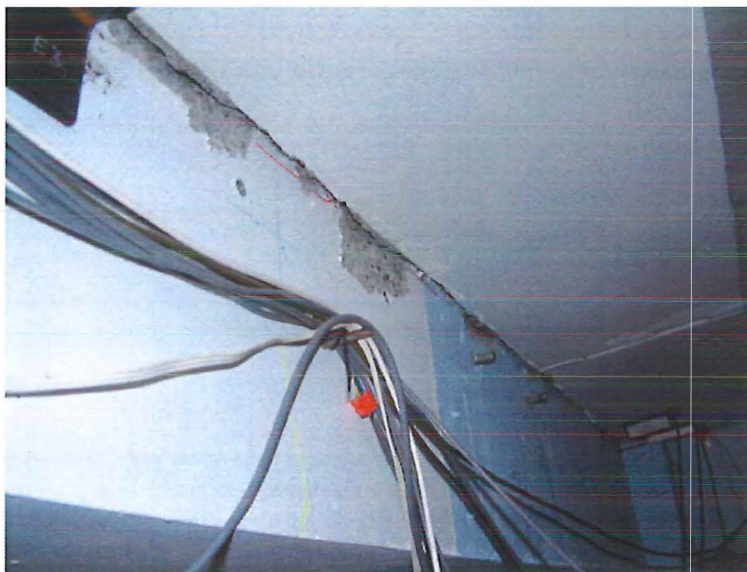
(a) Spalled beam cover on the hollow-core seat.

(b) The entire seat of the hollow-core unit has been lost

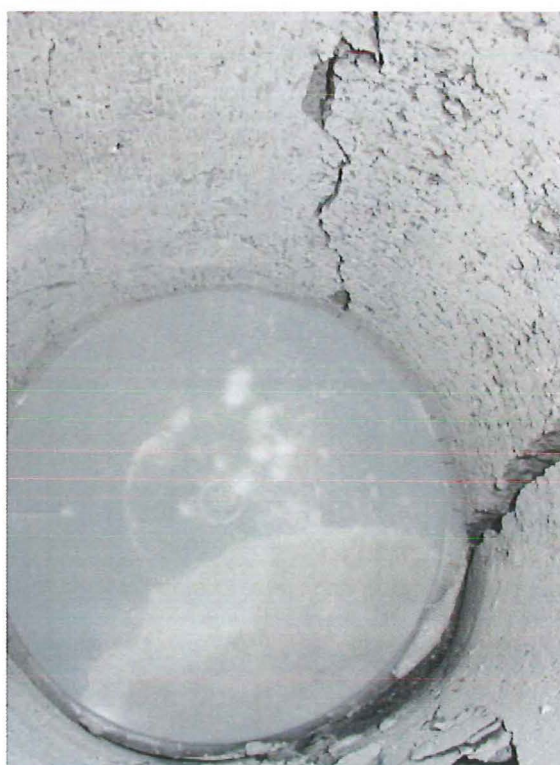
(a) Section of the hollow-core unit that fell out allowing a camera inside

(b) Looking east. Large cracks can be seen in the web and soffit of the unit.

(c) Several cracks can be seen around the dam. Extensive damage to the seat connection as well as the unit

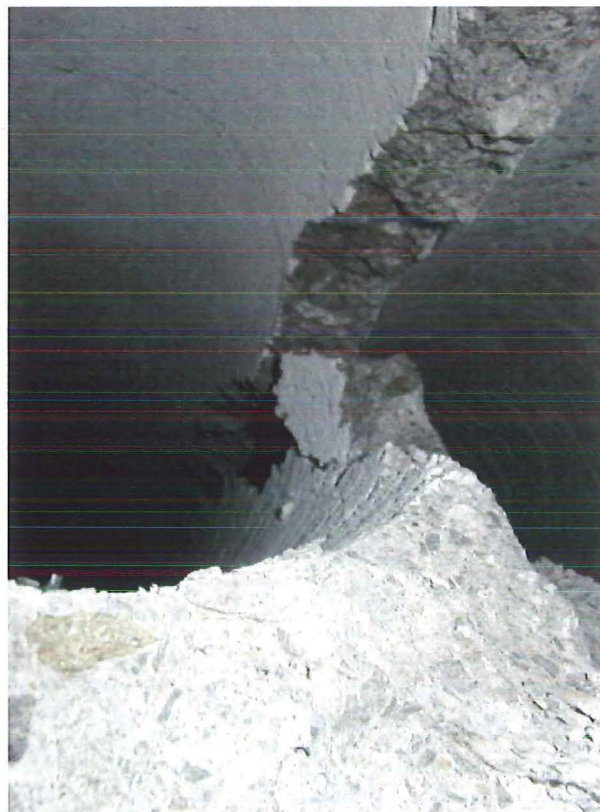
(b) Photo showing the width of web crack in the hollow-core unit
